**Flood Control Project Maintenance
Levee Inspections****LMA District Cover Sheet****Spring 2011 Levee Inspection Results****Levee District No. 0003 (Glenn County)**

Levee Inspection Report By Mile - Spring 2011

Levee District No. 0003 (Glenn County)

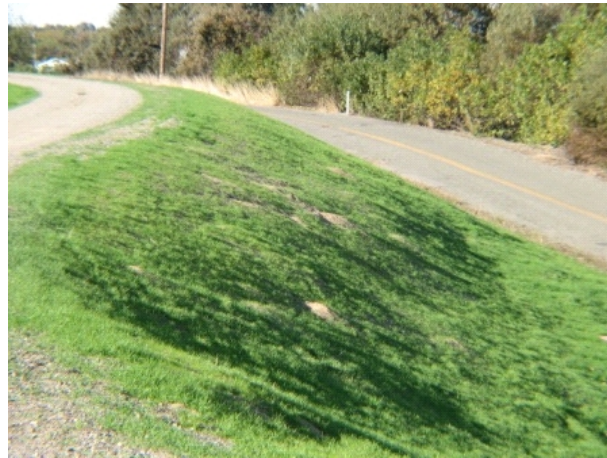
Levee Mile Report Line	1
Start Levee Mile	0.23
End Levee Mile	0.29
Location	Land Side
Category	Earthen Levee
Item	Animal Control

View of squirrel holes along the slope.

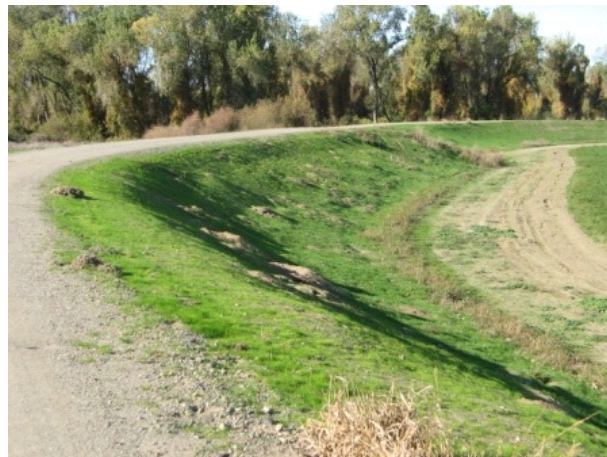
Levee Mile Report Line	4
Start Levee Mile	0.75
End Levee Mile	0.75
Location	Land Side
Category	Earthen Levee
Item	Animal Control

View of squirrel holes along the slope.

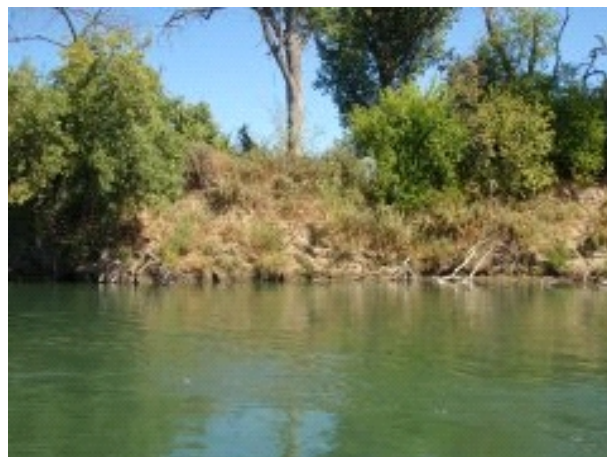
Levee Mile Report Line	6
Start Levee Mile	1.41
End Levee Mile	1.61
Location	Water Side
Category	Supplemental
Item	USACE Erosion Survey

2009: 15 ft berm, 1:1 slope, tree hazards and slumping, clays and silts, 10.07 ft/s [2009 SiteID:SAC_163-0_L]

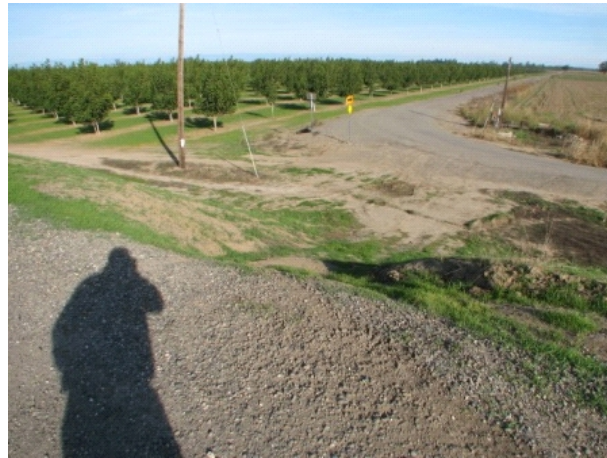
Levee Mile Report Line	10
Start Levee Mile	3.44
End Levee Mile	3.44
Location	Land Side
Category	Earthen Levee
Item	Slope Stability

View of the vehicle erosion on the landside slope of the levee.

10	3.44	3.44	Earthen Levee	Slope Stability	LS	M	Repair the levee slope damaged by vehicle traffic and prevent access where possible.	39.418267 ° -121.992472 °	39.418267 ° -121.992472 °	9 Y
11	3.50	3.50	Earthen Levee	Animal Control	LS	M	No rodents visible, but rodent burrows visible; need to backfill and compact or grout burrows.	39.419232 ° -121.992345 °	39.419232 ° -121.992345 °	16
12	3.81	3.81	Earthen Levee	Animal Control	LS	M	No rodents visible, but rodent burrows visible; need to backfill and compact or grout burrows.	39.423490 ° -121.991730 °	39.423490 ° -121.991730 °	18
13	3.82	3.82	Earthen Levee	Slope Stability	LS	M	Repair the levee slope damaged by vehicle traffic and prevent access where possible.	39.423747 ° -121.991667 °	39.423747 ° -121.991667 °	19 Y
14	3.84	3.84	Earthen Levee	Animal Control	WS	C	No rodents visible, but rodent burrows visible; need to backfill and compact or grout burrows.	39.423975 ° -121.991490 °	39.423975 ° -121.991490 °	20

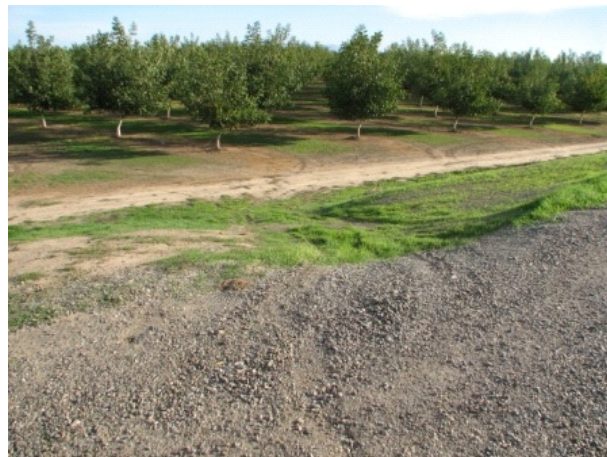
Levee Mile Report Line	13
Start Levee Mile	3.82
End Levee Mile	3.82
Location	Land Side
Category	Earthen Levee
Item	Slope Stability

View of vehicle erosion on the slope.

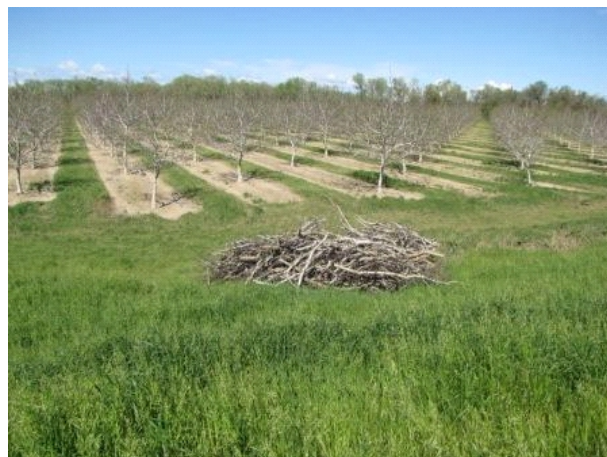
Levee Mile Report Line	15
Start Levee Mile	4.25
End Levee Mile	4.25
Location	Water Side
Category	Earthen Levee
Item	Encroachments

View of prunings along the W/S toe.

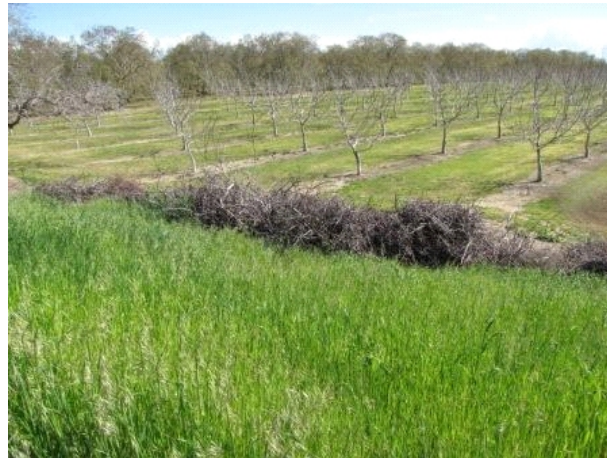
Levee Mile Report Line	16
Start Levee Mile	5.15
End Levee Mile	5.15
Location	Land Side
Category	Earthen Levee
Item	Encroachments

View of pruning along the L/S toe.

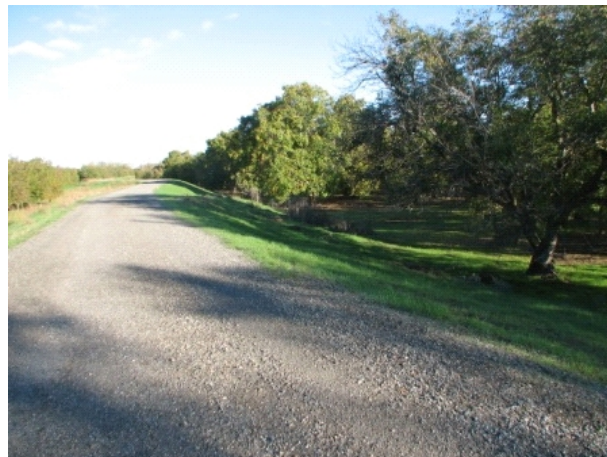
Levee Mile Report Line	17
Start Levee Mile	5.17
End Levee Mile	5.30
Location	Land Side
Category	Earthen Levee
Item	Trim / Thin Trees

View of squirrel along the slope.

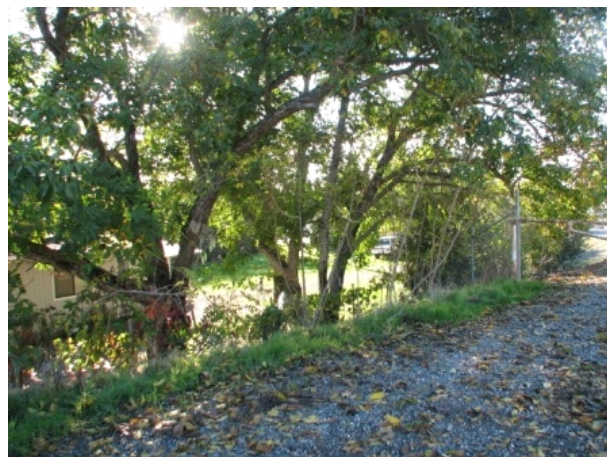
Levee Mile Report Line	31
Start Levee Mile	6.88
End Levee Mile	6.88
Location	Land Side
Category	Earthen Levee
Item	Trim / Thin Trees

View of the trees that are hanging over the landside slope of the levee.

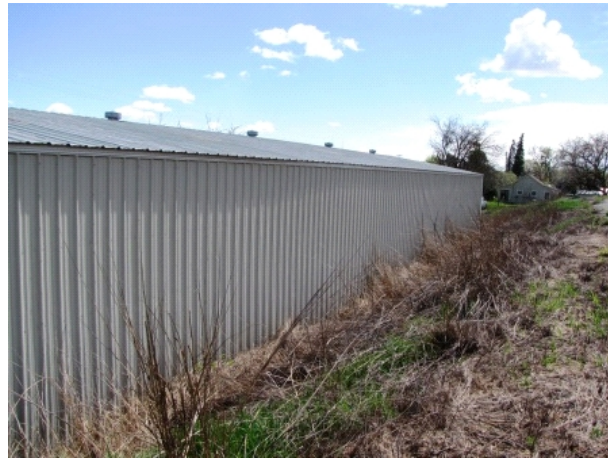
Levee Mile Report Line	32
Start Levee Mile	6.91
End Levee Mile	6.92
Location	Land Side
Category	Earthen Levee
Item	Encroachments

View of the building along the L/S toe.

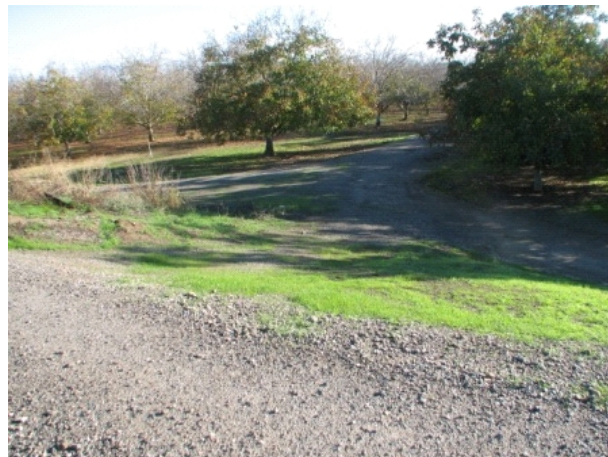
Levee Mile Report Line	34
Start Levee Mile	7.34
End Levee Mile	7.34
Location	Land Side
Category	Earthen Levee
Item	Slope Stability

Vehicle erosion along the slope.

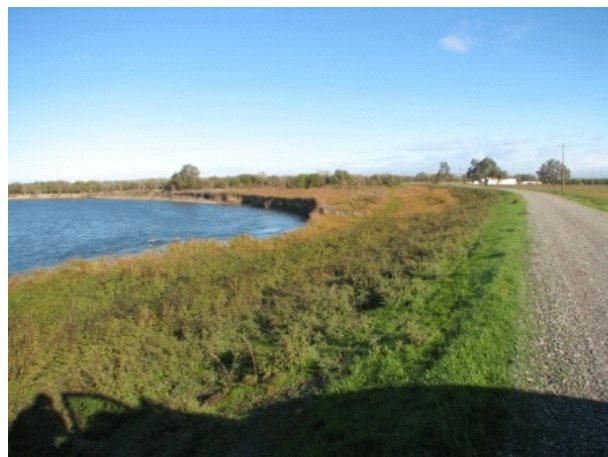
Levee Mile Report Line	42
Start Levee Mile	9.88
End Levee Mile	9.88
Location	Water Side
Category	Earthen Levee
Item	Erosion / Bank Caving

Erosion 30 ft from the levee toe.

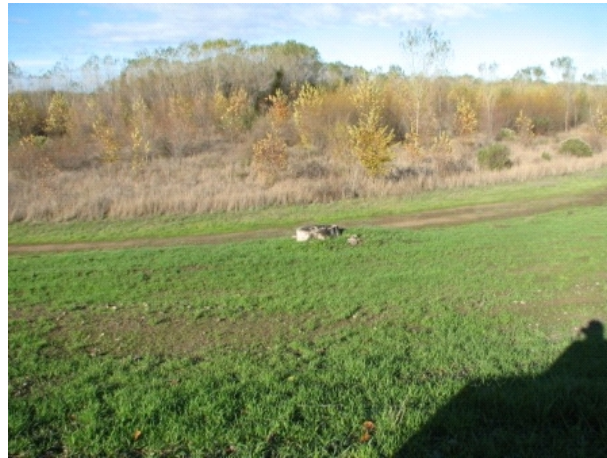
Levee Mile Report Line	44
Start Levee Mile	10.73
End Levee Mile	10.73
Location	Water Side
Category	Earthen Levee
Item	Trim / Thin Trees

view of the stump along the toe.

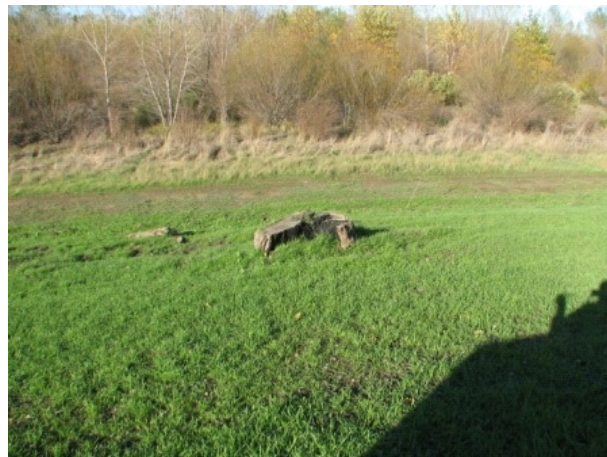
Levee Mile Report Line	45
Start Levee Mile	10.90
End Levee Mile	10.90
Location	Water Side
Category	Earthen Levee
Item	Trim / Thin Trees

View of the stump along the slope.

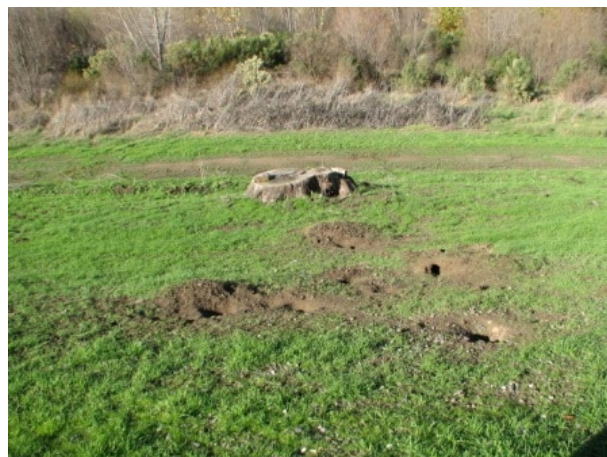
Levee Mile Report Line	46
Start Levee Mile	11.05
End Levee Mile	11.05
Location	Water Side
Category	Earthen Levee
Item	Animal Control

View of the squirrel holes along the slope & also a tree stump.

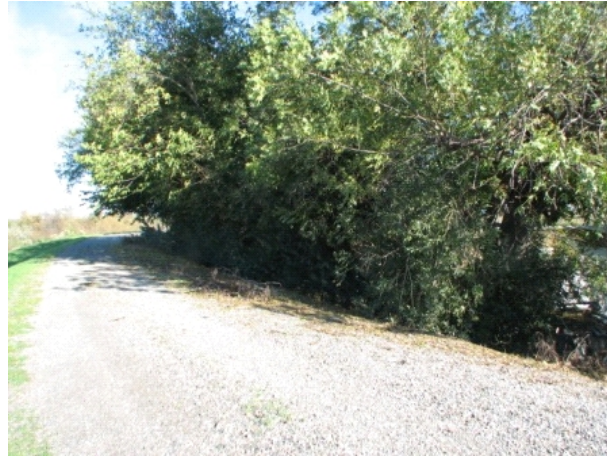
Levee Mile Report Line	48
Start Levee Mile	11.22
End Levee Mile	11.25
Location	Land Side
Category	Earthen Levee
Item	Trim / Thin Trees

View of the trees along the slope.
